# MacBook Pro 15" Touch Bar 2019 Teardown

Written By: Arthur Shi

## INTRODUCTION

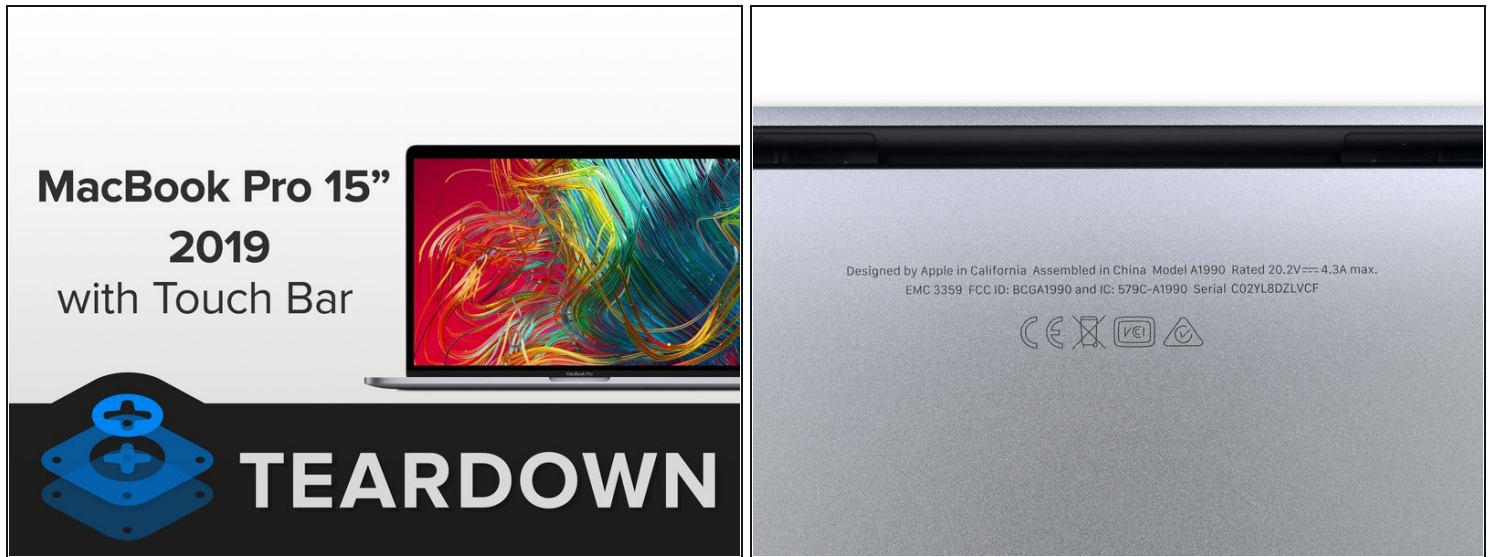
## Step 1 — MacBook Pro 15" Touch Bar 2019 Teardown

- On paper, this new 2019 MacBook Pro is only a spec bump—but just how bumpy is it? Let's recap:
  - 15.4" LED-backlit IPS Retina display with True Tone, 2880 x 1800 resolution (220 dpi), P3 wide color gamut
  - 2.6 GHz 6-core Intel Core i7 (Turbo Boost up to 4.5 GHz) paired with a Radeon Pro 555X
  - 16 GB of 2400 MHz DDR4 SDRAM
  - 256 GB PCIe-based SSD
  - 802.11ac Wi-Fi and Bluetooth 5.0
  - Four Thunderbolt 3 (USB-C) ports
- ① Our teardown victim bears the familiar A1990 model number, but a new EMC number: **3359**.

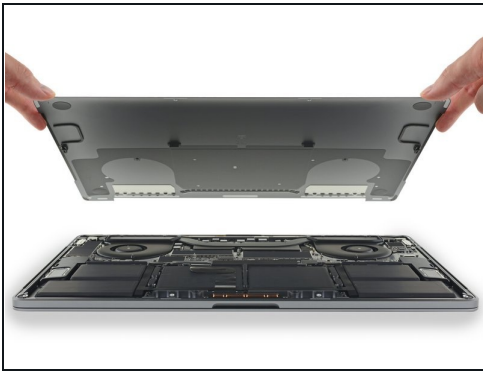
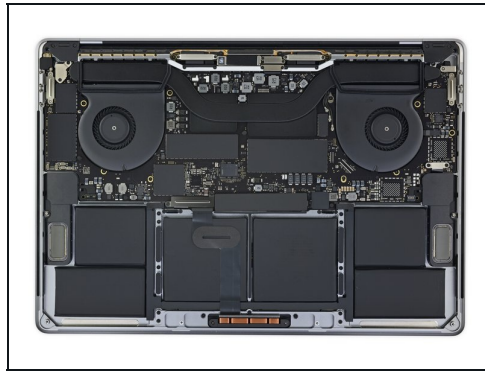
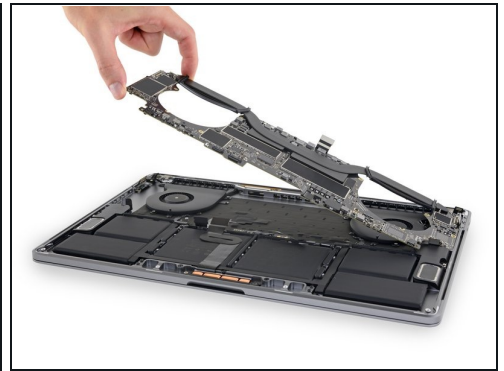
## Step 2

- Last time, we needed two [different teardowns](#) to get to the bottom of one of these laptops—so for once, let's skip the formalities.
- Just like a cooking show, we cut out the nitty and get to the gritty—*voilà!* It's open!
  - ⓘ If you *are* curious about how to get inside, it's exactly the same procedure as the 2018 edition ... which we [already have guides for!](#)
- As promised, this is looking *mostly* like a spec bump—the hardware appears visually indistinguishable from last time. Let's pull the board and look closer.

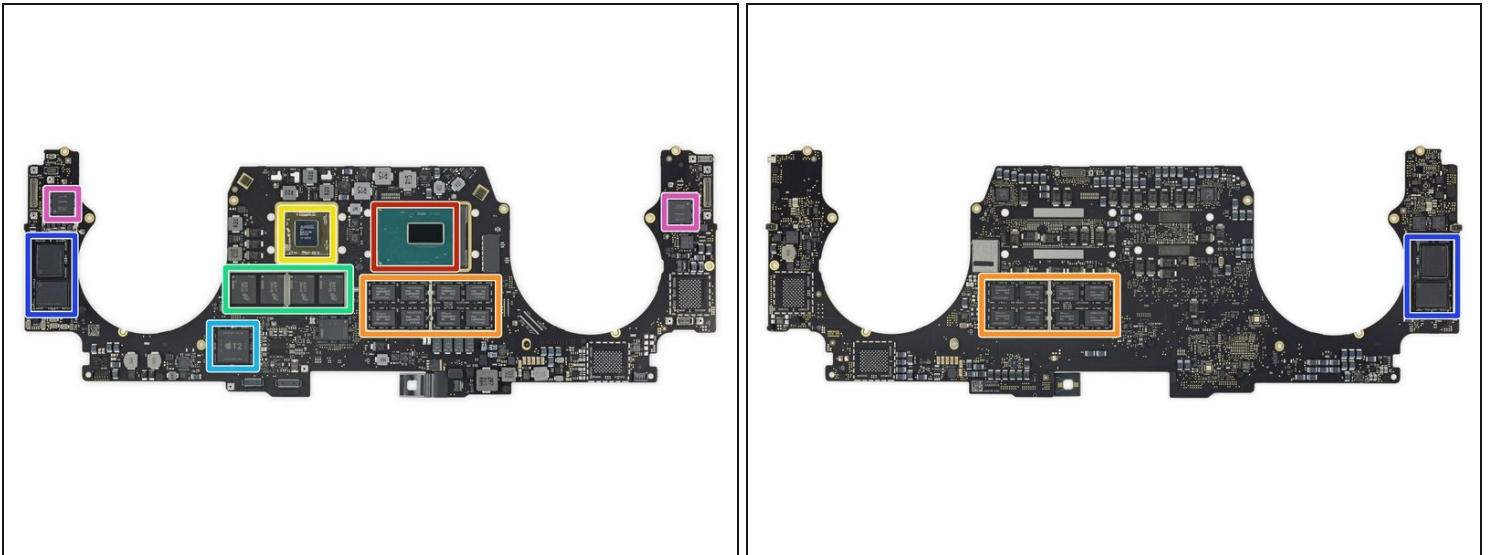
### Step 3

- With zero modular components, there's no chance of upgrading any of this hardware. Speak now or forever hold your chips:
  - 9th-generation Intel Core [i7-9750H](#) 6-core processor
  - 16x SK Hynix [H5AN8G8NAFR](#) 8 Gb DDR4 SDRAM (16 GB total)
  - AMD Radeon Pro 555X GPU
  - 4x Micron [MT51J256M32HF-70:B](#) 8 Gb GDDR5 RAM (4 GB total)
  - Apple T2 APL1027 339S00533 coprocessor, layered over 1 GB Micron D9VLN LPDDR4 memory
  - Toshiba TSB3226AW8815TWNA1 and TSB3226XZ2939TWNA1 flash storage (256 GB total)
  - Intel [JHL7540](#) Thunderbolt 3 controller

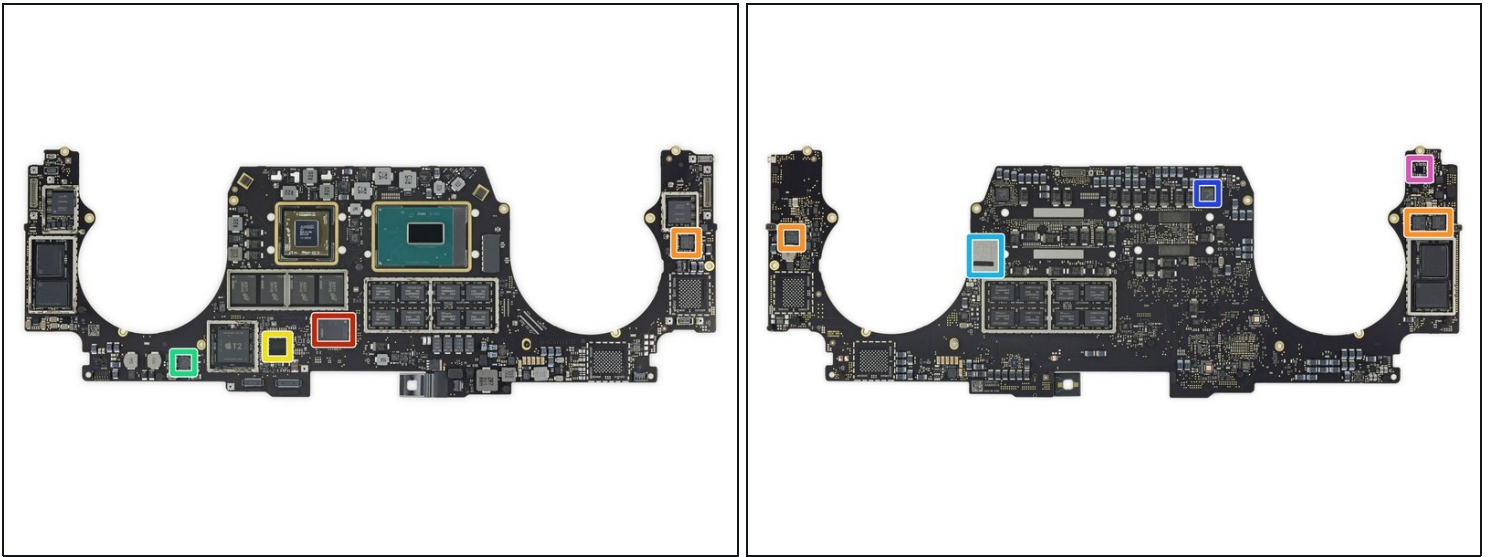
## Step 4

- More chips for your perusal:
  - Intel [SR40F](#) platform controller hub
  - Texas Instruments CD3215C00Z (likely power controllers)
  - 338S00267-A0 (likely Apple PMIC)
  - TPS51980A power controller
  - 339S00458 (likely Apple Wi-Fi/Bluetooth module)
  - Intersil [6277A](#) PWM modulator
  - Cirrus Logic CS42L83A audio codec

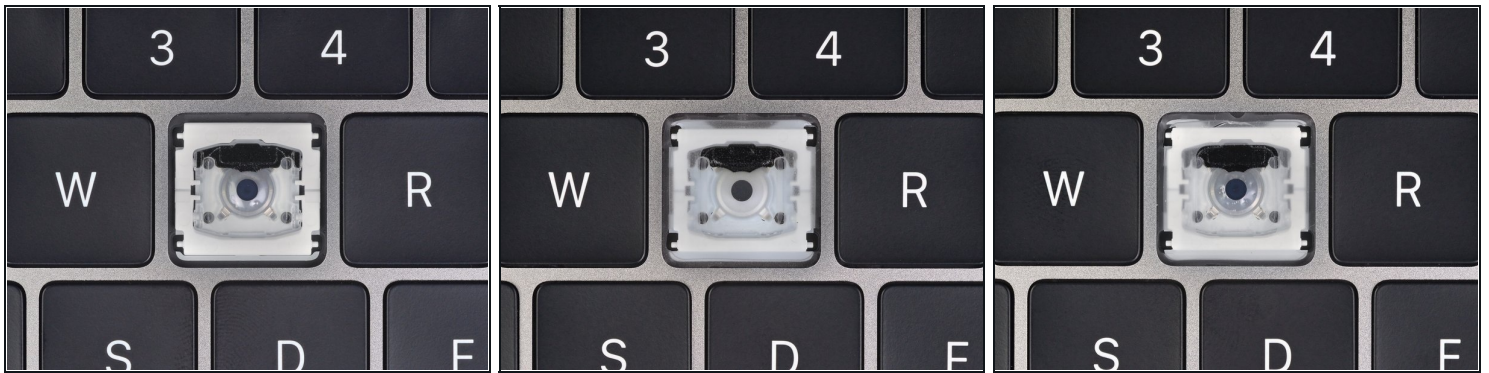
## Step 5

- Onward to the keyboard! Let's recap this butterfly's metamorphosis so far.
- After making its debut in the 2015 [Retina MacBook](#), the butterfly keyboard landed on the MacBook Pro line for the first time in 2016 (pictured at left).
- ⓘ Designed to be super thin while accommodating off-center key presses, the keyboard proved controversial because of its extremely short throw—but soon proved unreliable as well.
- In summer of 2018, [Apple launched a repair program](#), privately blaming dust for jamming the keys—and released updated models with a [silicone membrane](#) protecting the key switches (middle image). [But problems have persisted.](#)
- Lastly, 2019's butterfly switch revision keeps the silicone membrane, but tweaks the materials in the springy metal dome and the plasticky material that covers it.

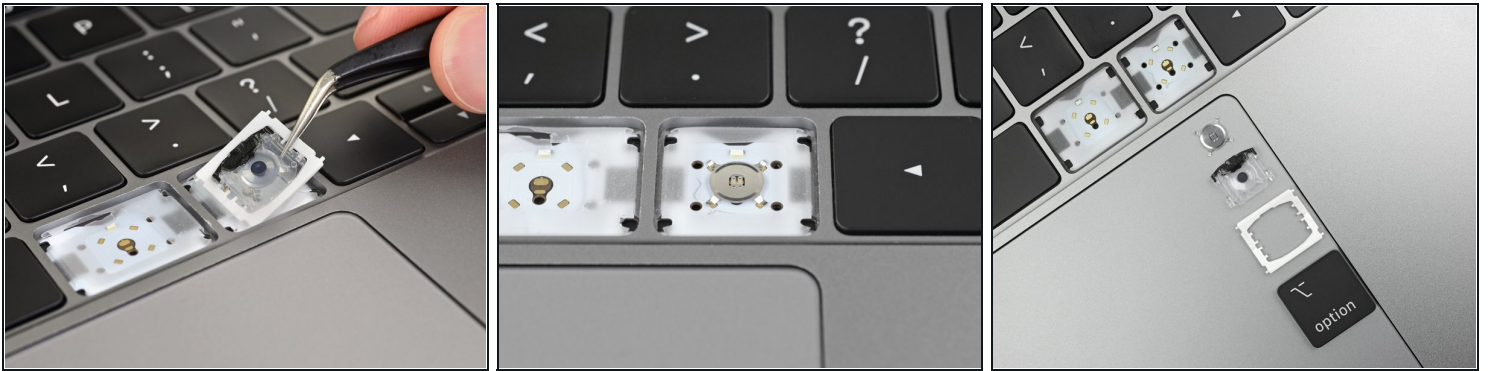
## Step 6

- Now that we have some context, let's go layer by layer through the *key* components of 2019's butterfly switch:
  - Topping it all off is the key cap. This has a handy label to tell users which key is broken.

- The hinged white bracket is the "butterfly" mechanism controlling the key's motion—stabilizing it so as to travel up and down without tilting or wobbling.

- Nesting within that bracket is a transparent cover that flexes with each key press, while keeping contaminants away from the dome switch underneath. The black dot at its center concentrates the force of your key press onto the switch.

- The main character of this assembly is the springy [metal dome switch](#). It deforms when the key is pressed, bridging the board's six contacts—and then bounces back when you release the key.

- Underneath the dome switch are [six metal pads](#). A keystroke registers whenever the top center pad is shorted to any of the other five pads.
  - To wrap it up, the silicone membrane covers the butterfly mechanism to keep debris from getting in and jamming it.

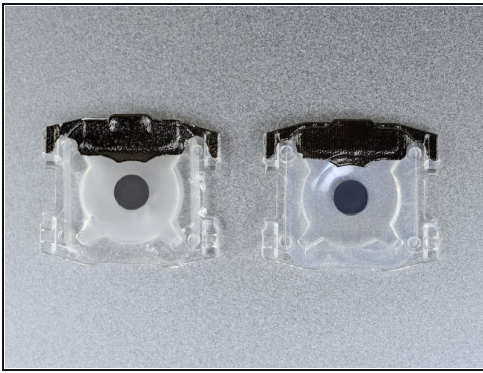
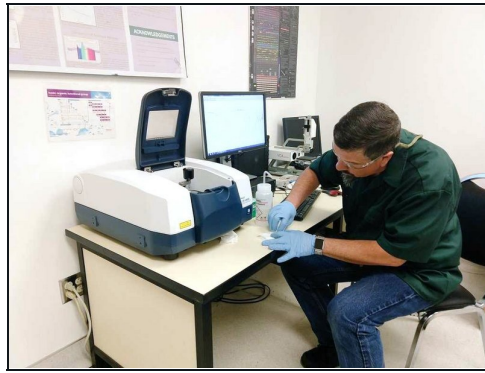
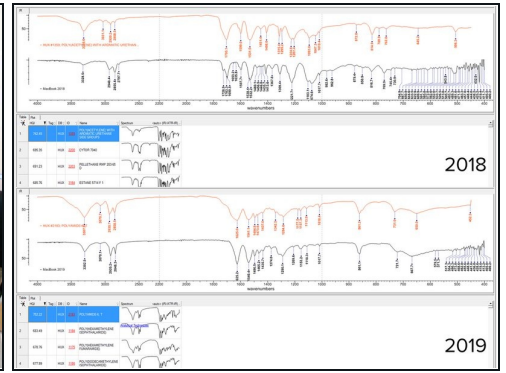
## Step 7

- So, what changed this year? First, the transparent switch cover material.
  - The cover in the 2018 model is semi-opaque, somewhat tacky, and feels like silicone. The new model is clearer and smooth to the touch.

- To confirm that the materials are indeed different, we analyzed them using Fourier Transform Infrared (FTIR) spectroscopy. Thanks to Eric Beaton and [Cal Poly's Materials Engineering department](#) for their equipment and expertise!

- ❶ [FTIR analysis](#) works by shining infrared light at a material and measuring how much light is absorbed and at what wavelengths. This data acts like a fingerprint that can be used to identify the material.

- [The differing peaks and valleys](#) on the [FTIR spectra](#) for the two samples show us that they *are* different materials. But what are they?
  - When comparing these FTIR spectra to that of known polymers, the closest match for the 2018 model is either poly(acetylene) with aromatic urethane side groups, or a type of TPU (which seems more likely). The 2019 model is a match for polyamide (commonly known as nylon).

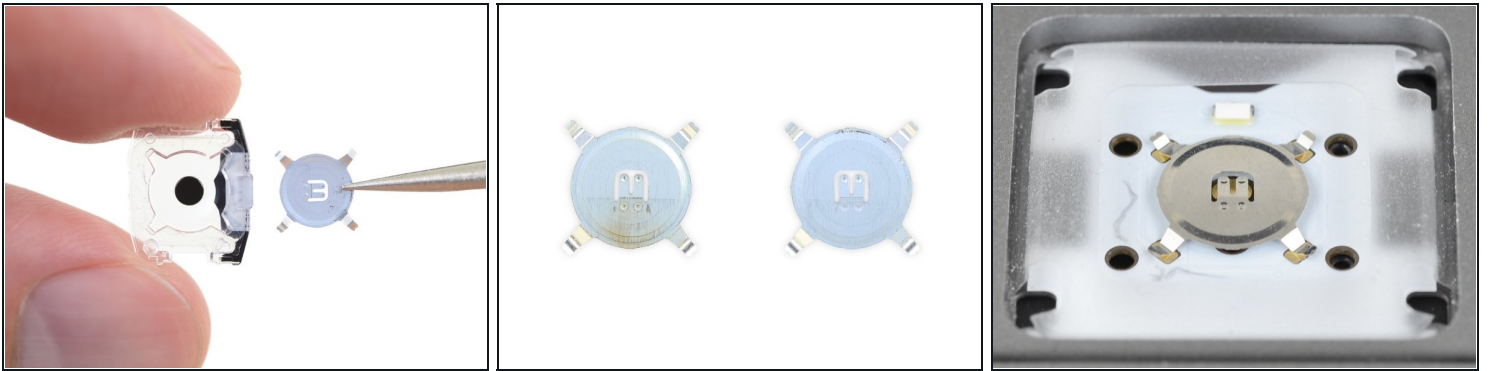
## Step 8

- What else changed? We think the metal dome switch may have. Let's look closer.
  - The dome is like a really tiny [jam lid](#) or [Snapple cap](#)—you press down and it springs back up.

- If anything changes about the dome—if it's cracked or deformed—the key may behave erratically. Likewise, if the prongs break or bend, the key stops working.

- ① There are myriad possible reasons for this switch to crack or wear out—manufacturing defects, plain old fatigue, prolonged heat, moisture, outgassing from other components, and corrosion are all common culprits.

- 📌 These switches are also magnetized from the factory. Best guess as to their composition: ferritic stainless steel, with a thin polymer coating on the bottom. The difference in surface finish from the 2018 version (left) to the 2019 (right) indicates Apple may be using a revised heat treatment, or alloy, or possibly both.

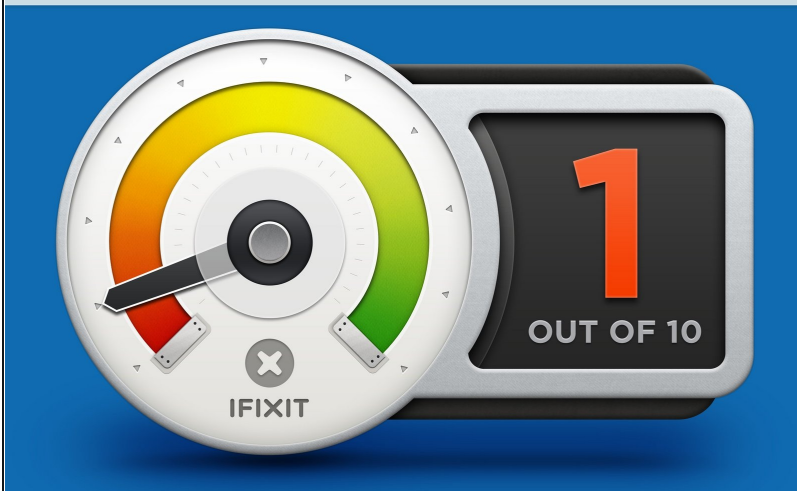
### REPAIRABILITY SCORE:

- The 2019 MacBook Pro 15" with Touch Bar earns a **1 out of 10** on our repairability scale (10 is easiest to repair):
  - The trackpad can be removed and replaced with very little drama.
  - The processor, RAM, and flash memory are soldered to the logic board. Repairs and upgrades will be impractical at best.
  - The top case assembly, including the keyboard, battery, speakers, *and* Touch Bar, is glued together—making all those components impractical to replace separately.
  - The Touch ID sensor doubles as the power switch, and is paired with the T2 chip on the logic board. Fixing a broken power switch may require help from Apple, or a new logic board.
