# Samsung LED TV LE37A659 (and similar models) T-Con Board Replacement

Written By: Arwedus

Color problems, like a “negative image” look or a gradual shift to white or dark “low contrast” picture, can be fixed on multiple TV models by replacing the T-Con board (for “timing controller”).

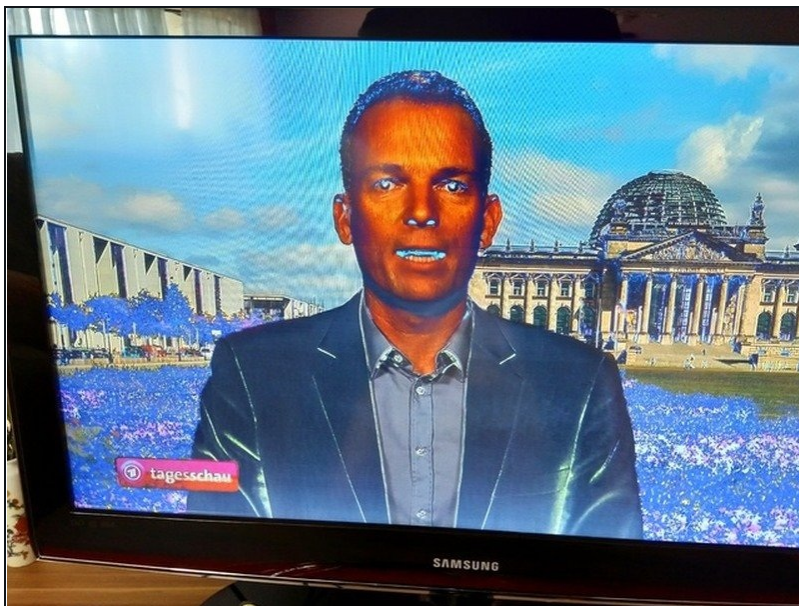
## Step 1 — Check whether the issue is with the T-Con board

- Typical symptoms: moiré patterns, "negative image" colors, colors with low contrast and turning white or dark over time, image distortion. See sample pictures.

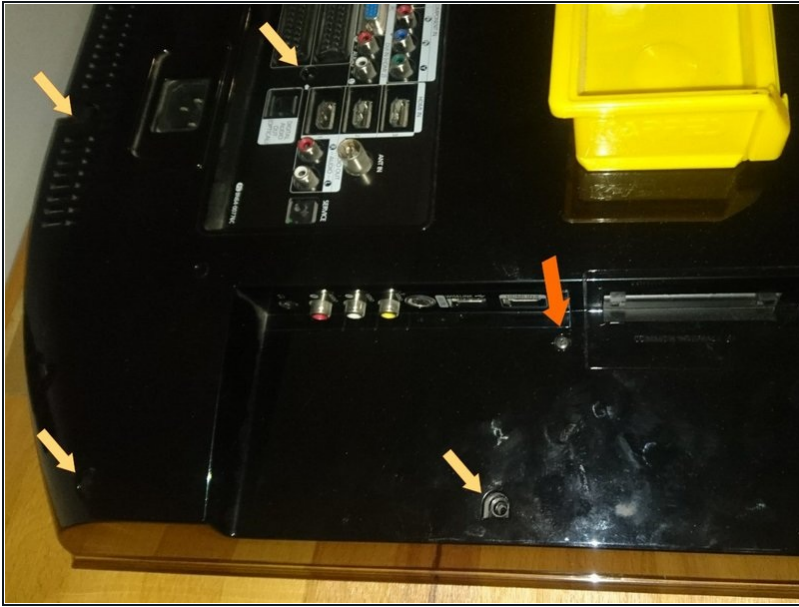
## Step 2 — Open the back cover

- Put the TV on a large, flat surface with the display facing down.
- Loosen all screws which hold the back cover. They are all the same size except for one (which is marked with an orange arrow in the picture). Be careful with the four screws in the lower center region - they hold the stand (the base).
- Take off the back cover without applying force. Collect all screws in a box or leave them sticking in the back cover - inside you will have more screws of the same type and you don't wanna lose count.

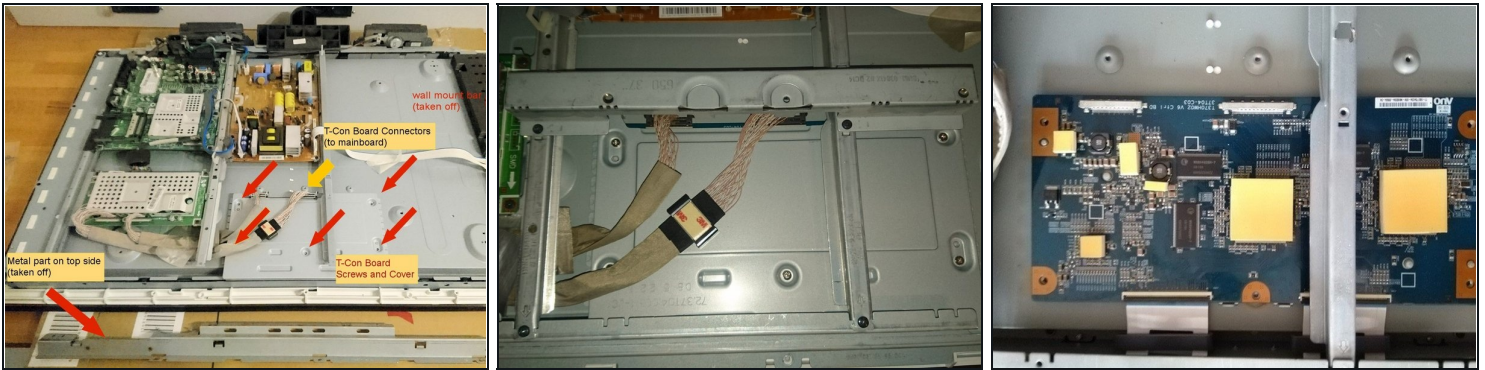
### Step 3 — Removing the T-Con Board

- This is the interior of the TV, with the top facing you (bottom side of the picture). You see the power supply board in the center, and the main board. The T-Con board is hidden by a metal cover.
- To get to it, we will have to remove all screws on the parts that cover it. Luckily, the screws are marked with an arrow symbol.
- Remove the wall mount bar by loosening the two screws.
- Remove the metal part on the top which also is blocking access to the T-Con board.
- Remove the T-Con board connectors.
- Remove the 5 screws holding the T-Con boards and it's metal cover.
- Now you can carefully shift away the metal cover of the T-Con board below the other metal bar.
- Two flat ribbon cables are connected from the display to the T-Con board. They can be removed by carefully unlocking the socket (take some plastic lever or your fingernail and turn up the black hinge).

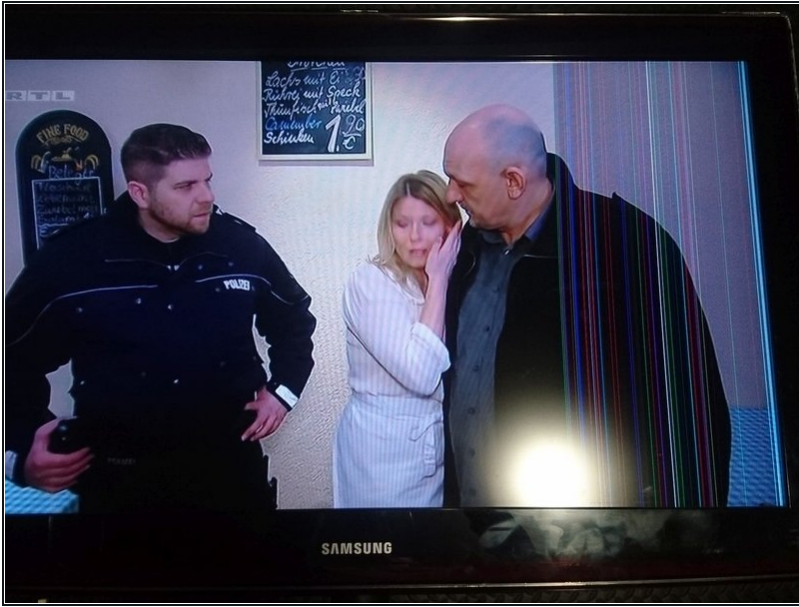
## Step 5 — Reassembly

- Carefully put back the flat ribbon cables in the socket and push down the black lever.
- Continue with putting everything back together in the reverse order as you disassembled it.
- If you test your TV now, and vertical stripes appear which were not in the picture before (see sample picture), the flat cable does not correctly sit in it's socket or some contact ends are loose / scratched off. Put the cable cleanly in the socket and fix it correctly.
