# Moto g power 2025

Moto g power 2025 Level 3 – Service Manual

# L3 Parts List and Image

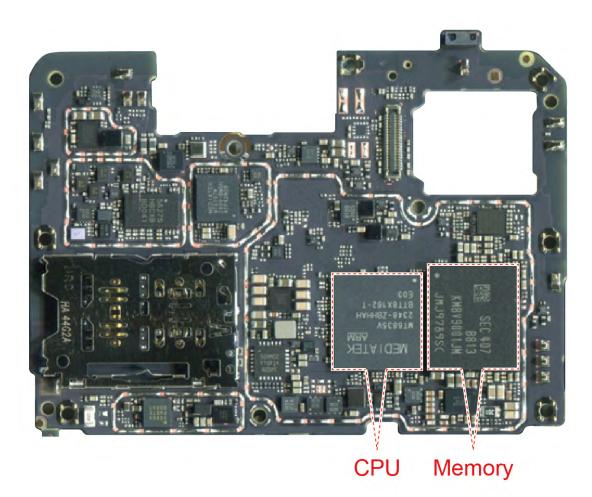
Figure 1. Front View

## **Front View**

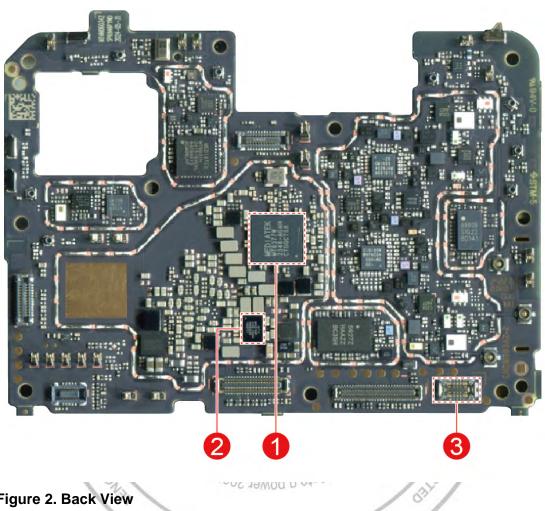
Figure 2. Back View

## **Back View**

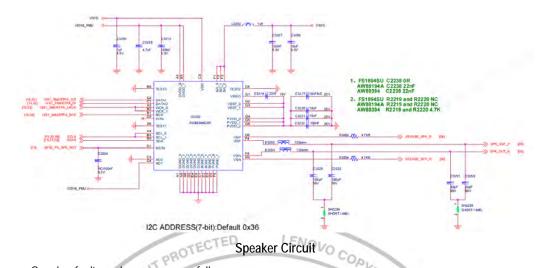
The speaker of the M383 mobile phone is on a small board and is connected to the motherboard via FPC. External power amplifier is used, and the channel device is on the motherboard. The schematic diagram of the speaker audio output is as follows:

- 1. Reasons why SPK has no ringtone:
  - Whether the SPK itself is broken, or the SPK is missing:
  - Whether there is any abnormality in the SPK path device on the small board;
  - Whether the FPC connected to the motherboard and the small board is loose or falling off;
  - Whether the audio PA (U2001) is defective;
  - The above picture is whether there is a problem with the device on the SPK\_OUT\_P/N;
  - Software Issues.

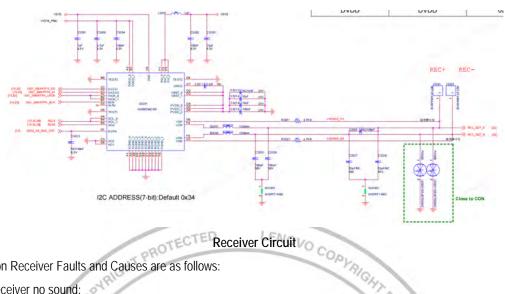
The earpiece of the M383 mobile phone is embedded in the front case of the mobile phone and connected to the motherboard by a shrapnel. Mainly used for phone calls. The following figure shows the receiver loop.

- 1. Receiver no sound:
  - Receiver is poorly assembled, and the shrapnel and board are in poor contact;
  - Virtual soldering of devices on AU\_HSP/N lines;
  - Receive ontology is bad;
  - Volume setting or software problems.
- Receiver noise or low volume: 2.
  - Receiver incoming material is poor;
  - Device soldering problems or burnout on the AU\_HSP/N line;
  - Software issues.

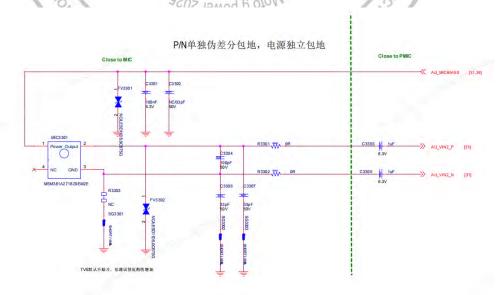
The schematic diagram of the secondary MIC loop on the motherboard is as follows:

- 1. MIC cannot send or record:
  - MIC welding is poor;
  - False soldering of devices on the motherboard MIC\_P/N line;
  - Ground filter capacitors and ESD devices are short-circuited to ground;
  - The MIC body is bad; (If there is no sound after testing the MIC recording, it is also possible that the speaker channel is bad).

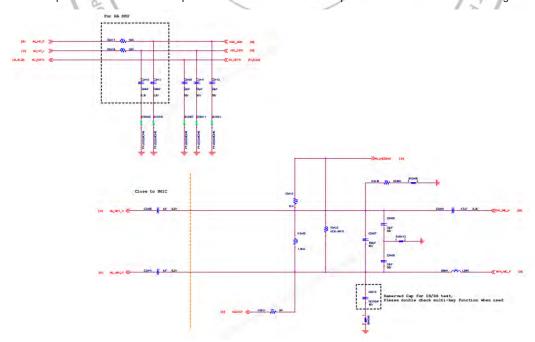
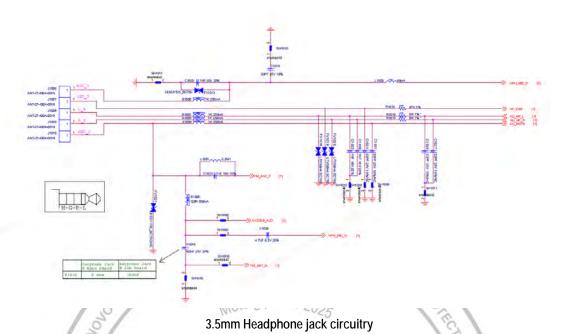
The headphones used in the M383 phone are standard 3.5mm headphones. The circuit schematic diagram is as follows:

- The headphones have no sound:
  - The headphones are not plugged in;
  - Earphone connector pad virtual soldering;
  - Whether the device on the AU\_HP\_L/R line is soldered or damaged;
  - Whether there is damage to the TVS and capacitance to the ground;
  - The relevant circuits inside the chip are damaged or soldered.
- The earphone cannot be identified when inserted and unplugged: 2.
  - The earphone detects whether the circuit device on the HP\_EINT is soldered or damaged;
  - Whether the shrapnel of the earphone socket is in good contact with the motherboard;
  - ESD device short circuit to ground;
  - Software reasons.
- LENOVO COPYRIGHT P. The MIC of the earphone does not send a call:
  - The earphone is not plugged in place.

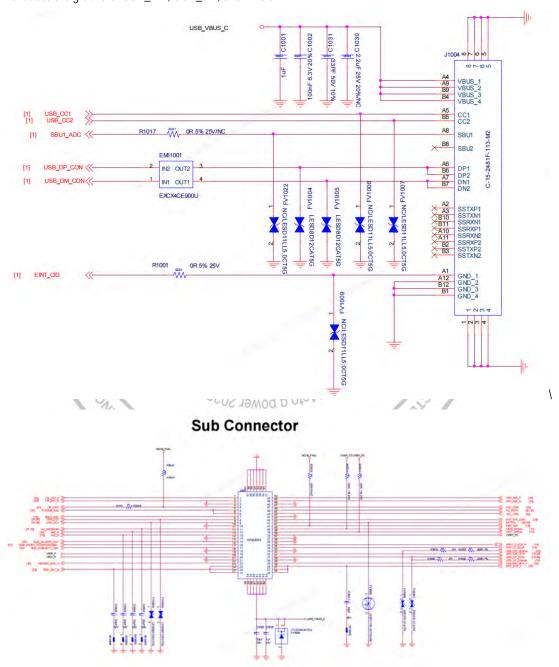
- 1. The mobile phone cannot be turned on, please refer to the maintenance due to the failure to turn on;
- 2. The USB test point is oxidized, and there is no good contact with the fixture;
- 3. USB connector virtual welding;
- 4. Due to the USB circuit itself, please check whether the device is soldered and whether it is connected to the test point. Whether the TVS device and the surge device to the ground are reversed or broken down, resulting in a short circuit to the ground of USB\_DM, USB\_DP, and VBUS.

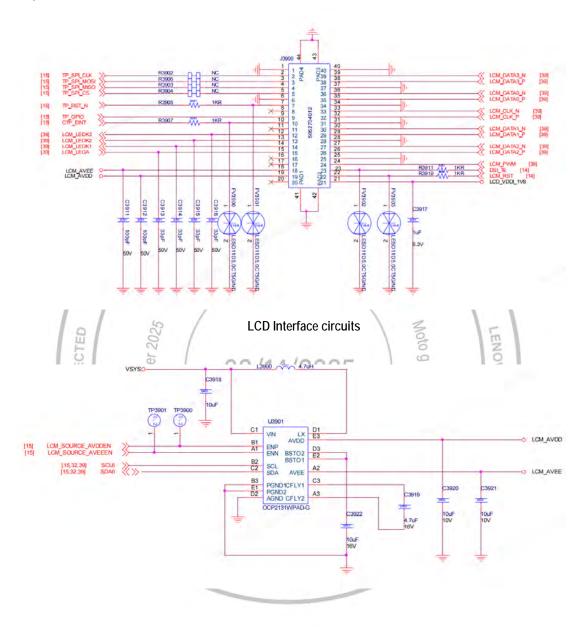
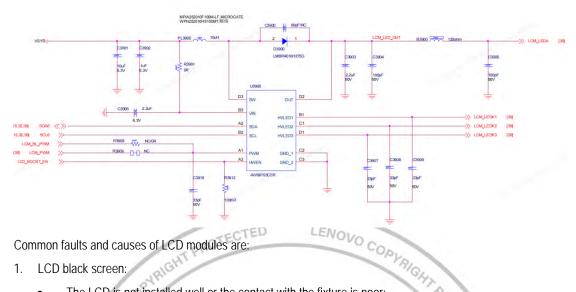
The M383 uses a 6.78-inch LCD that is connected to the motherboard via a board connector. The schematic diagram of this part of the circuit is as follows:

- 1. LCD black screen:
  - The LCD is not installed well or the contact with the fixture is poor;
  - If the LCD backlight circuit is broken, check whether the backlight enable pin is pulled up, check whether the backlight chip circuit has soldering problems, and check whether the backlight IC input and output pin PWM control pin is normal;

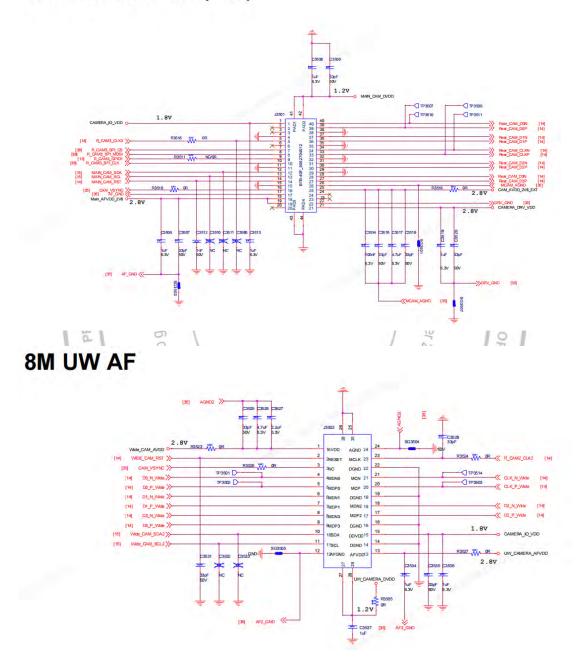
#### Rear Camera 50M(OIS)

M383 is designed for three cameras, one front camera is connected to the motherboard through connector J3503, one rear main camera is connected to the motherboard through connector J3501, and one rear auxiliary camera is connected to the motherboard through connector J3502. The control of the Camera is done via the I2C bus.

- Camera initialization failed, and the main interface of Camera cannot be entered: LENOVO COPYRIGHT PROJECTION
  - Camera contact is poor;
  - Camera body failure;
  - The power supply of Camera Power is abnormal
  - EMI device problems, virtual soldering or tin damage;
  - The software is abnormal.
- The Camera preview screen or color is abnormal:
  - The Camera is not in good contact;
  - EMI device soldering problems; \$202 Jamod 6 olow
  - Reboot after factory reset.
- Camera can't store photos:
  - The memory of the body is insufficient, and there is no T card inserted;
  - The software is abnormal.
- For other problems with the Camera, please replace the Camera and try to confirm whether the Camera itself is faulty.

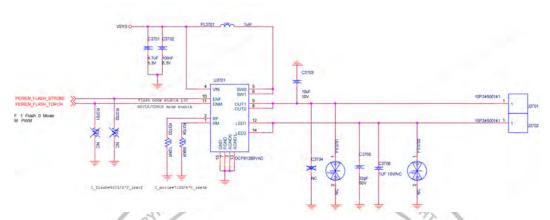
M383 rear flash:

- Chip virtual soldering;
- The flash body is damaged or soldered.

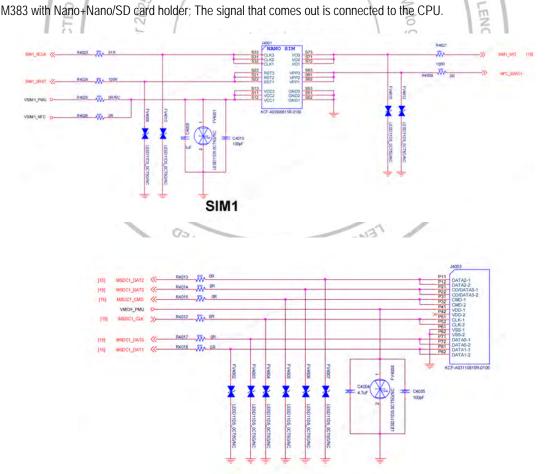
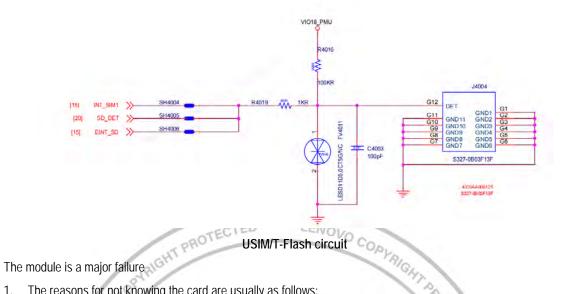
M383 with Nano+Nano/SD card holder; The signal that comes out is connected to the CPU.

- The reasons for not knowing the card are usually as follows:
  - Poor contact of the card seat;
  - The ESD protection device is broken down and short-circuited to the ground;
  - Whether there is virtual welding in the card seat;
  - Whether the card is inserted beyond the stroke or reversed.
- T-Flash read and write test failure:
  - T-flash is a faulty card;

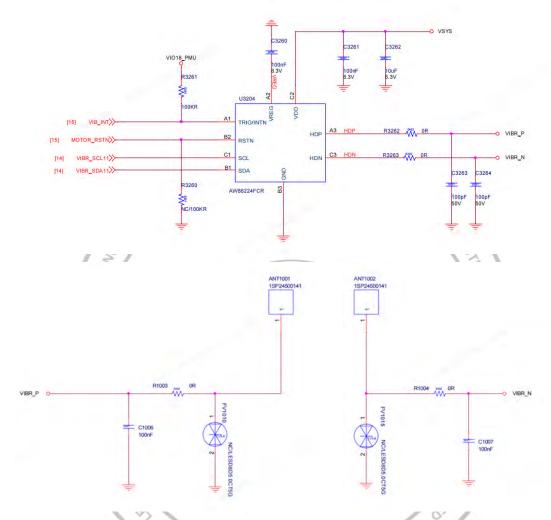
The M383 uses a linear motor, located on a small board, which is connected to the motherboard through FPC, and the motor drives the positive and negative outputs of the IC.

- 1. No vibration of the motor:
  - The shrapnel of the small plate is in poor contact with the motor
  - The motor itself is bad.
- The motor has a weak sense of vibration;
  - The motor body is bad;
  - Software setting reasons.
- 3. The motor vibrates from time to time: the motor body is a problem.
- 4. Motor vibration noise:
  - Structural assembly problems;
  - Motor ontology reasons.

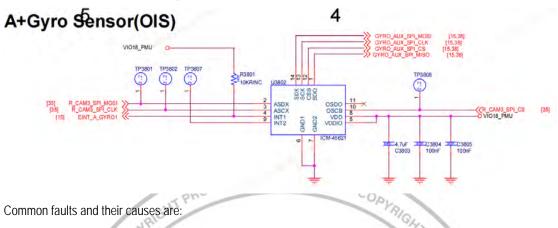
M383 A+G-Sensor SPI Data reading communication.

- Function NG: Check whether the module circuit has soldering or short circuit faults.
- Check whether the IC power supply is normal. Dower 2025

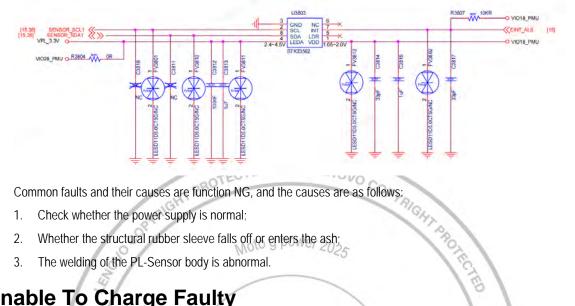
M383 PL-Sensor, I2C Data reading communication.

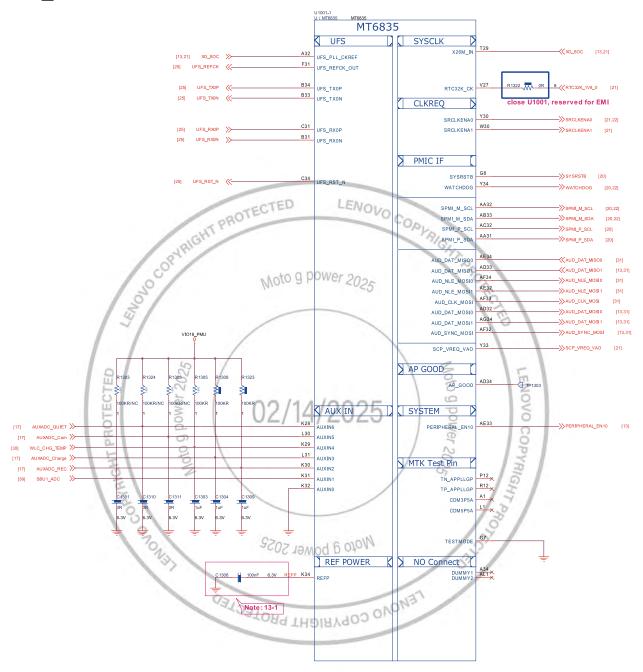
#### **BB\_1**

Schematic design notice of "BB\_1" page.

Note 1: The load cap. have to be placed as close to REFP ball as possible.

Note 2: "AUD\_DAT\_MOSI0" and "AUD\_DAT\_MOSI1" pin features in strapping pin to enable JTAG.

Note 3: "EINT1" and "PERIPHERAL\_EN10" pin features in strapping pin to booting (eMMC/UFS/Reserved).

Note 4: "AUD\_SYNC\_MOSI" and HW strapping pin to enable DDR.

Note 5: "AUD\_DAT\_MISO1" is MT6377 strapping pin to select VEMC Voltage.

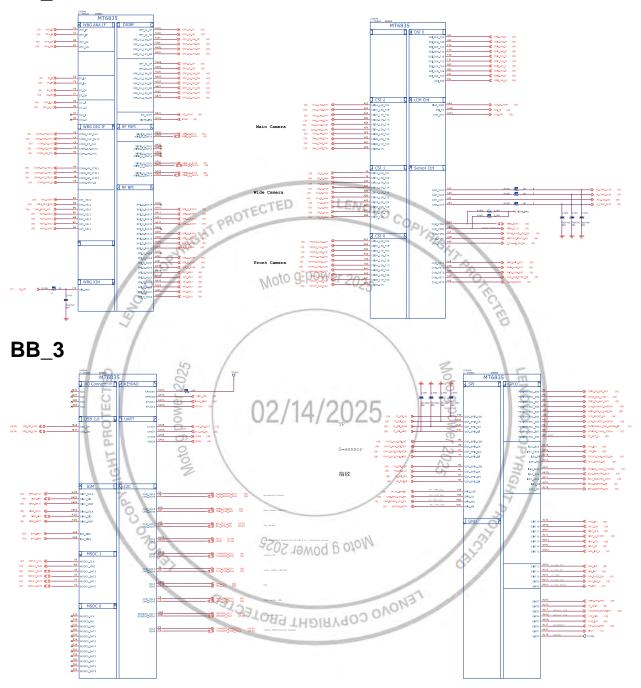
## **BB\_2**

Table 2-26. Mode selection

Pin name	Description	
[0] PERIPHERAL_EN10 [1] EINT1	00: UFS 01: eMMC 10: Forbidden 11: Forbidden	
[0] AUD_DAT_MOSI1 [1] AUD_DAT_MOSI0	00: Default 01: AP_JTAG_VCORE 10: MD_JTAG 11: DAP	
[0] AUD_SYNC_MOSI [1] EINT4 [2] EINT5	000: LP4x MCP 001: LP4x DSC

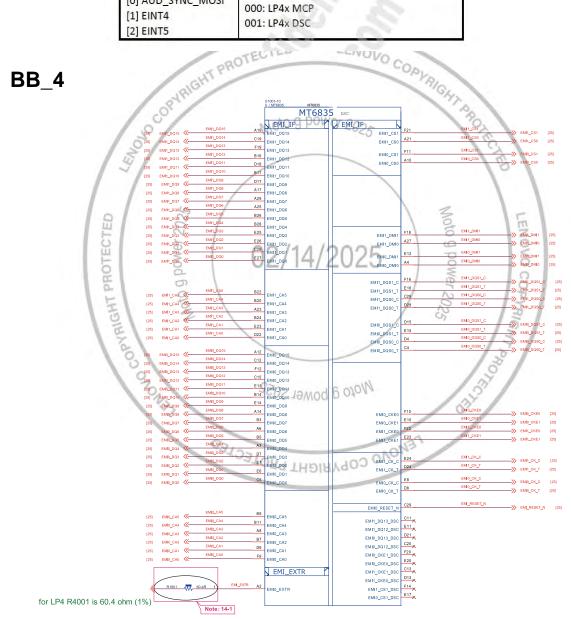
Schematic design notice of "BB\_4" page.

Note 1: for LP4 R4001 is 60.4 ohm (1%).

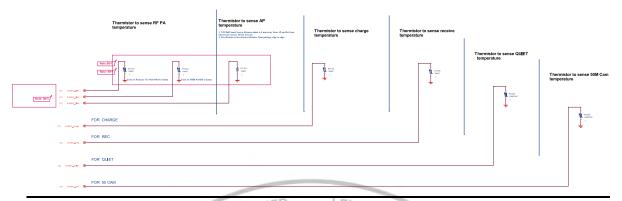
### BB\_AUXADC\_Thermal

Schematic design notice of "BB\_AUXADC\_Thermal" page.

Note 1: SW Default Configuration is as followings:

AUXADC\_VIN2: AP Temp.

AUXADC\_VIN3: MHB PAMiD Temp.

AUXADC\_VIN4: NR PAMID Temp.

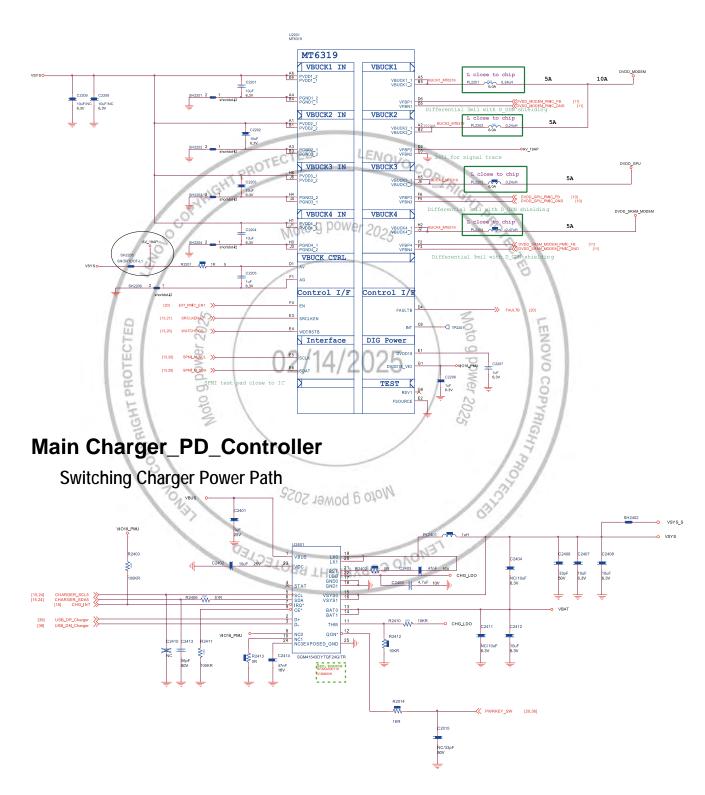
### POWER\_MT6319\_Buck

MT6319NP 4-Phase Buck (VMODEM, VSRAM\_MODEM, VGPU)

PMIC GND-ball connect to input cap. GND-pad firstly.

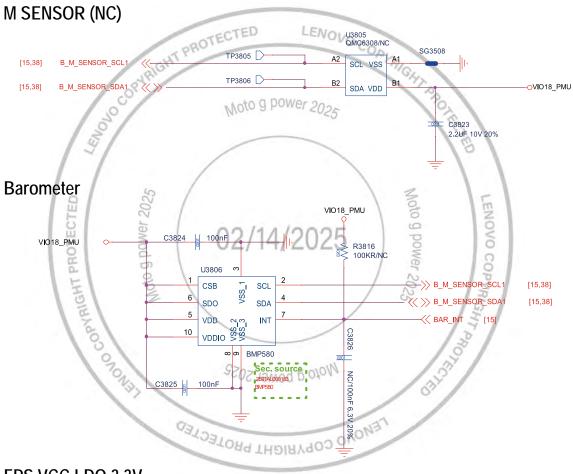
#### **M SENSOR**

QMC6308P I2C slave address: (W)OX58H, (R)OX59H

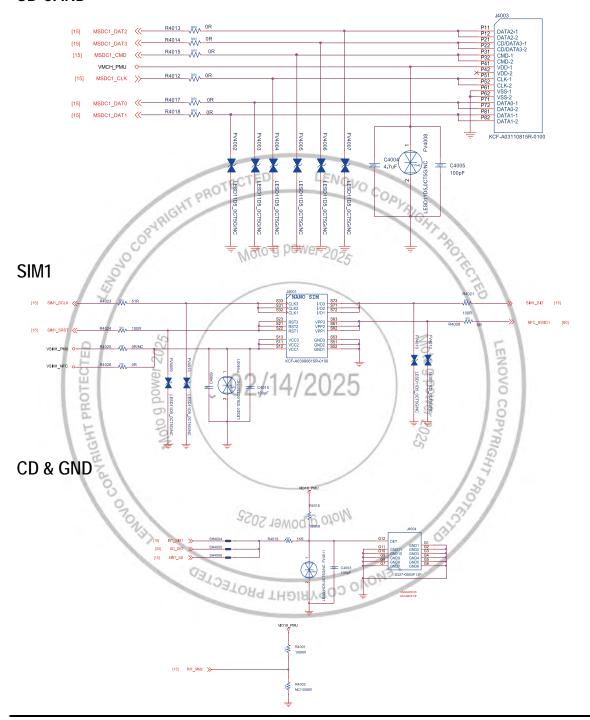
#### **SD CARD**

Schematic design notice of "SIM\_SD" page.

Note 1: Let Vpp pin no connect when NFC SIM function is not supported.

Note 2: For better ESD performance, please select suitable components for system protection.

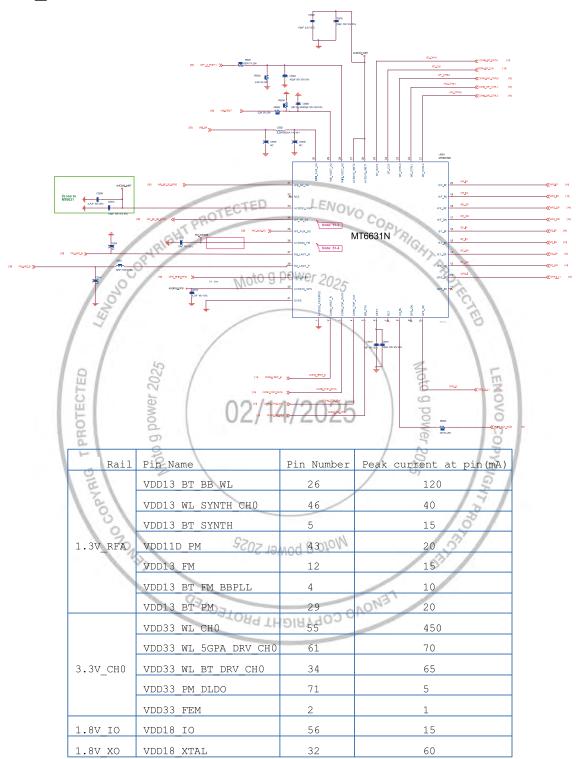
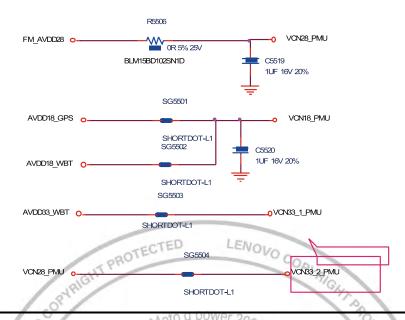
### **WCN\_MT6631**

#### Schematic design notice of "WCN\_MT6631" page.

Note 1: For R3808 size, please select 0402 size or larger one.

Note 3: If WiFi 5G not support, connect pin 34 (WF\_5G) to GND.

Note 4: Pin 36 (AVDD28\_FM) must be connected to VCN28 even if FM not support.
