# iPhone XS Max Face ID Not Working Fixed - Dot Projector Repair

Face ID Not Working 'Move iPhone a Little...

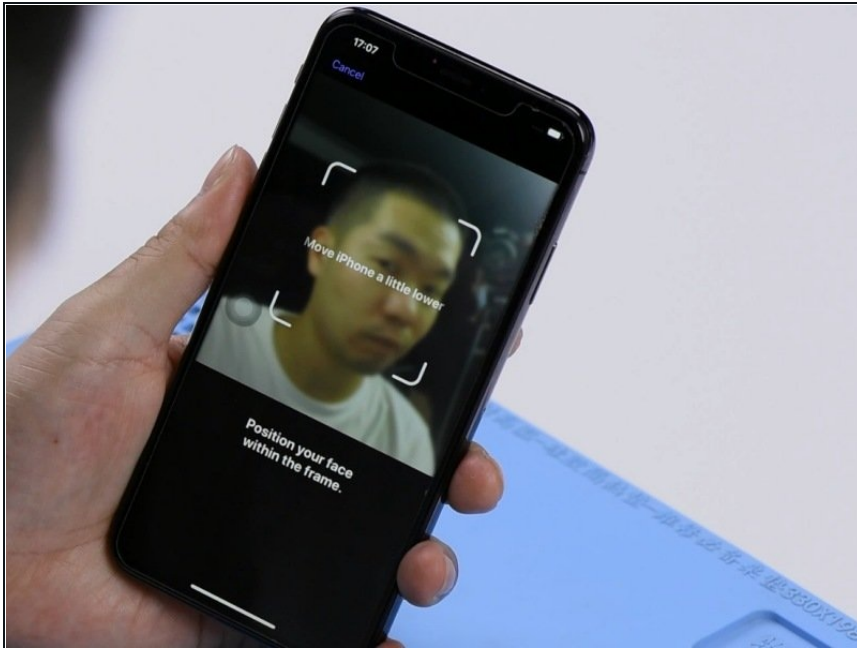
## Step 1 — Problem

- Go to Settings > Face ID & Passcode > Set Up Face ID. When trying to setup Face ID on the iPhone, we get the message 'move iPhone a little lower/higher'.
- Start the Camera app and select Portrait in the bottom bar. Switch to the front camera. When the camera detects a person's face, the name of the lighting effect 'Natural Light' stays the same. The pop-up notification keeps saying 'Move farther away'.
- Normally, when Portrait mode is ready, the name of the lighting effect 'Natural Light' should turn yellow.
- Judging by this, the dot projector or relevant circuits of the dot projector might have malfunctioned.

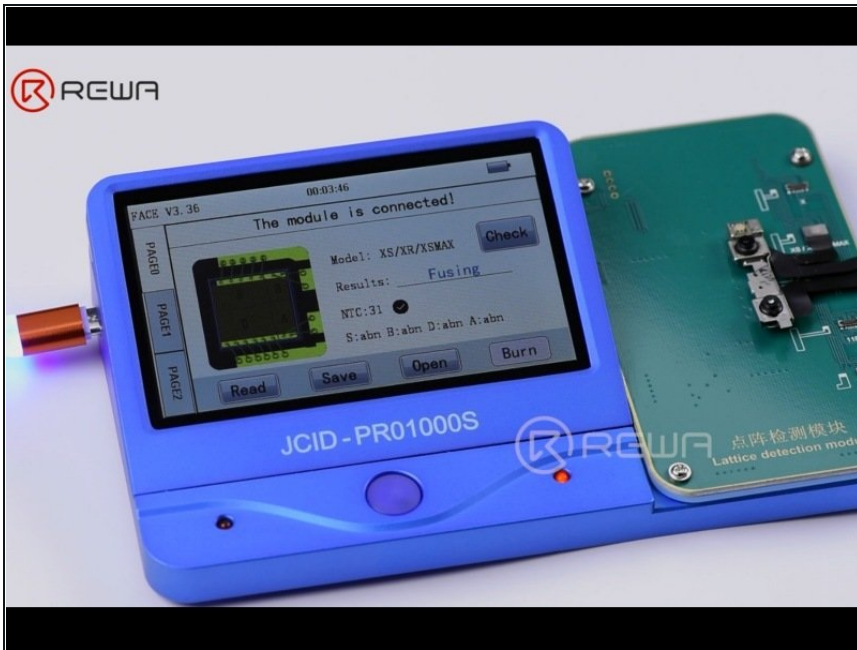
## Step 2 — Diagnosis

- Take apart the phone and remove the display assembly. We can see that the dot projector has been water damaged and the crystal on the dot projector is broken.
- Pull the battery adhesive strips out. Take out the front camera assembly.
- Connect the dot projector flex cable with the repair programmer. Click 'Check'. Results: Fusing.
- Judging by this, the dot projector flex cable has been damaged. We need to burn data of the original dot projector flex cable onto a new dot projector flex cable and then replace the broken crystal with a good one.
